Storm Damage Report

Memorial Inn & Suites
9535 Katy Freeway
Houston, Texas 77024

FIELD REPORT FOR INITIAL STORM DAMAGE INVESTIGATION

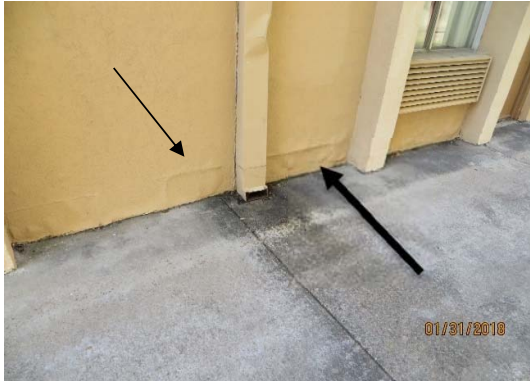
Figure 4

- Widespread damage identified to the exterior wall finish along the bottom of walls due to standing water during the tropical storm. This was observed by FBS and confirmed by property management. Water caused the parging to separate from the CMU at a number of locations. This damage typically extended up 12" from the grade line.

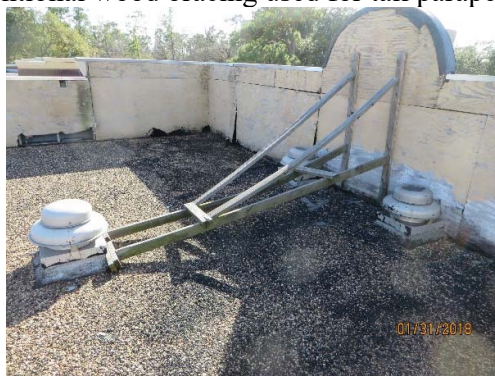
Figure 7

- 2" x 4" non-conventional wood bracing used for tall parapets.
